August 4, 2015
Revised October 2, 2015
ES-2953.03

Earth Solutions NW LLC

**Subject: Critical Areas Study
Westridge South
Northeast Discovery Drive and
7th Avenue Northeast
Issaquah, Washington**

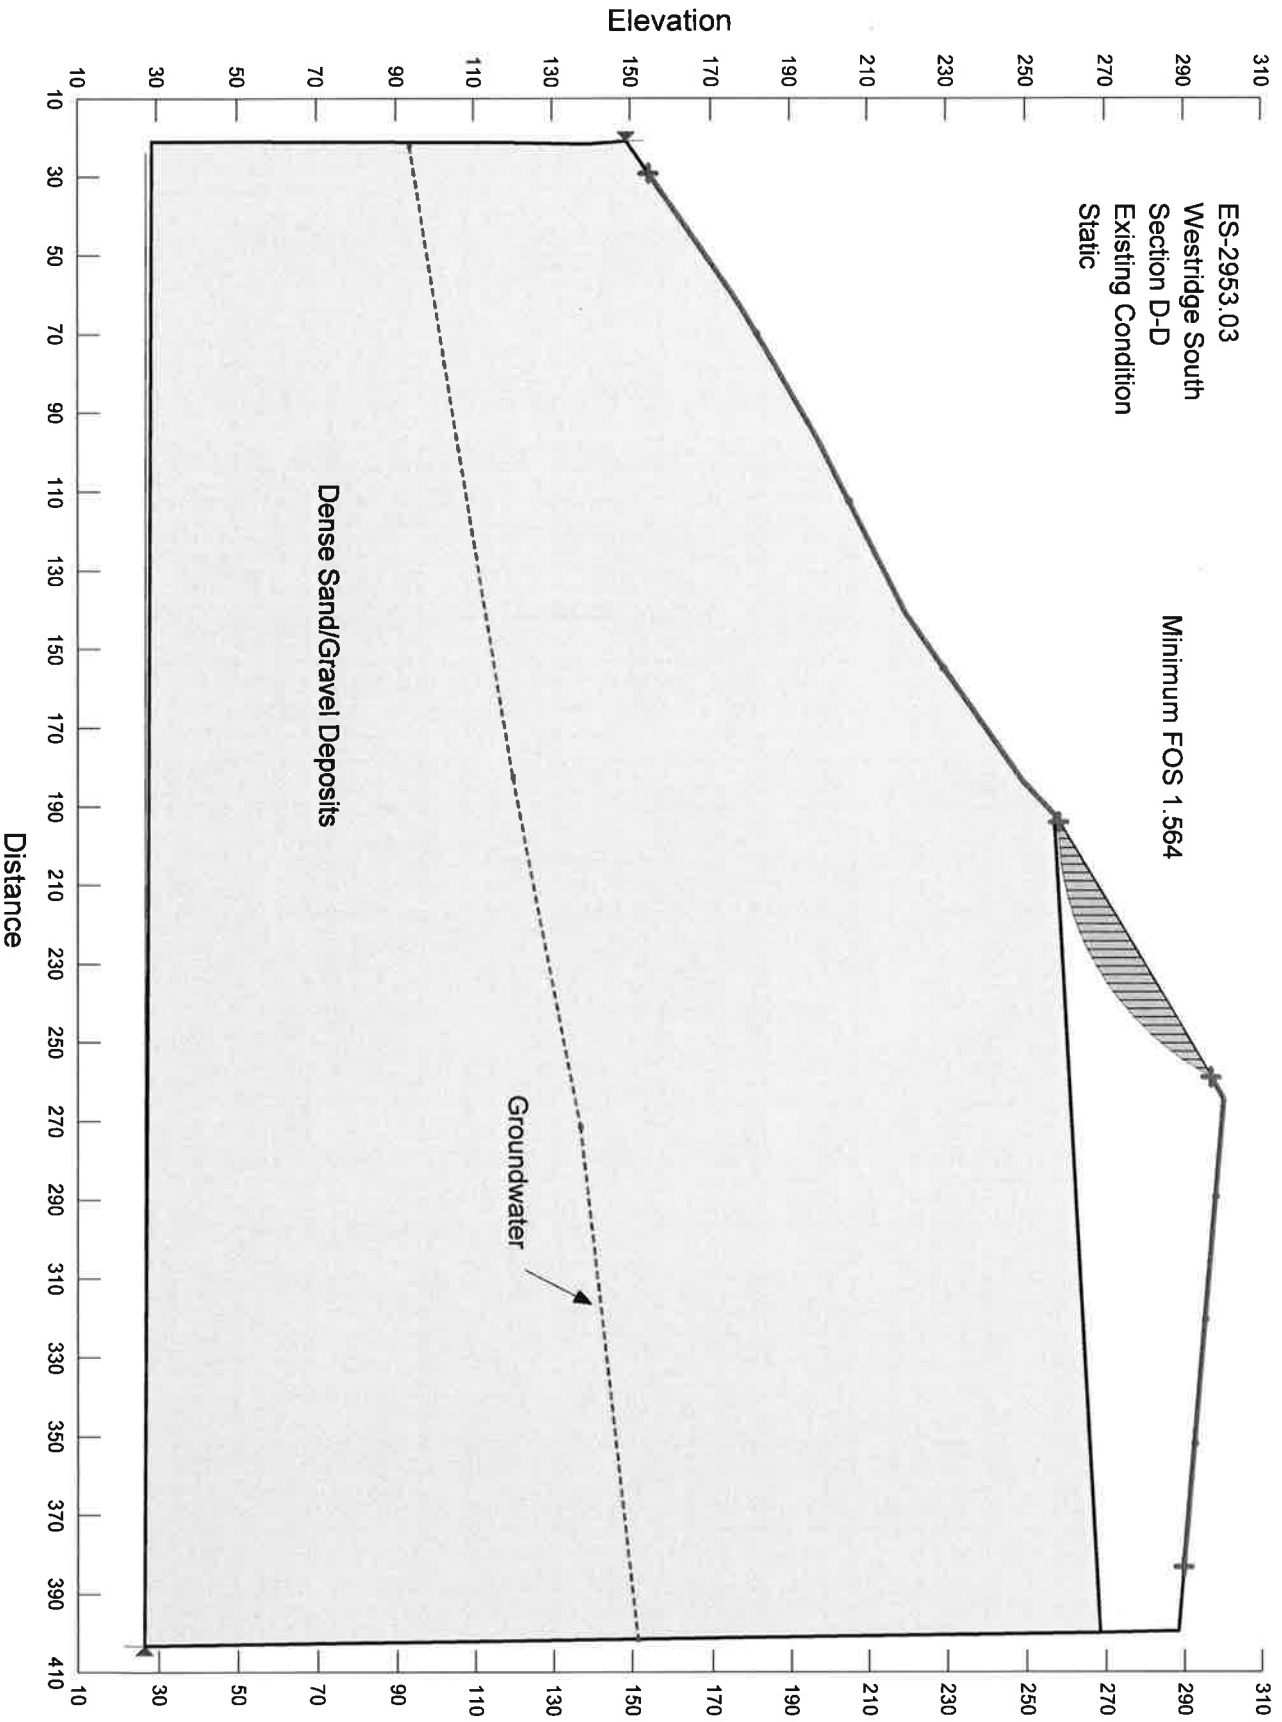
ES-2953.03
Westridge South
Section D-D
Existing Condition
Seismic

The analysis suggests that the steeper sloped areas are stable in a static condition. The analysis indicates that shallow debris-flow type failures are more common on this slope complex which is expected. Section D-D had the lowest static calculated FOS (1.564); however this critical failure surface was very shallow. When we looked at the failure plane through the proposed buffer and building setback, the calculated FOS increased. This type of failure mechanism is often related to natural weathering and excess water in the form of shallow interflow and/or surface flow. The analysis also indicates that the proposal, including the reduced buffer of 10 feet will not increase the potential for slope instability. In our opinion, this should be the primary criteria for evaluating a proposal because while there may be variations in the soil and groundwater information used for analysis in terms of a relatively homogenous slope complex, all things being equal, if a proposed configuration does not lower the calculated factor of safety, it should not pose an increased threat of instability on the areas evaluated. The information we reviewed regarding the soil and groundwater conditions within or near the subject property suggest that the slope is comprised of a fairly uniform sequence of ancient deltaic granular deposits.

FOS 1.054
