# **CRITICAL AREAS EVALUATION AND PRELIMINARY GEOTECHNICAL ENGINEERING REPORT**

**RGI PROJECT NO. 2015-046**

**BERGSMA PROPERTY  
SOUTHEAST NEWPORT WAY AND 17TH AVENUE NORTHWEST  
ISSAQUAH, WASHINGTON 98027**

**APRIL 1, 2015**

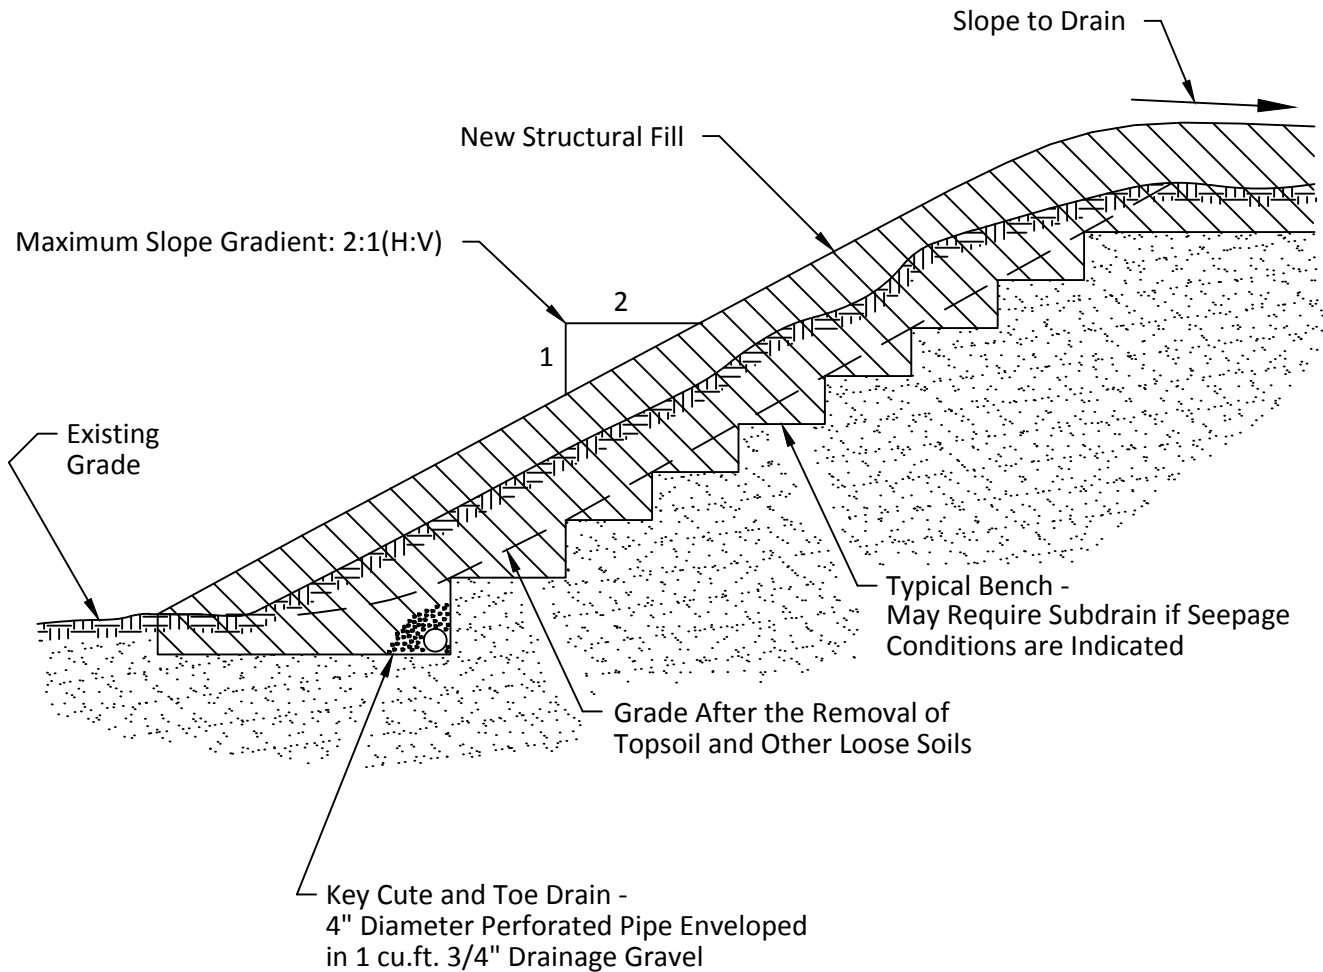
Bergsma Property		Figure 3
RGI Project Number 2015-046	General Slope Fill Detail	Date Drawn: 04/2015
Address: Southeast Newport Way and 17th Avenue Northwest, Issaquah, Washington 98072

1. Slope should be stripped of topsoil and unsuitable soils prior to placing any fill.
2. "Benches" should be a minimum of 6 feet wide.
3. "Key" should be minimum 2 feet deep and 6 feet wide, extending the full length of the slope face.
4. Final slope face should be densified by compaction.
5. Plant or hydroseed slope face to reduce erosion potential.
6. All structural fill should be compacted to 95% of soils maximum dry density per ASTM D-698 (standard proctor).

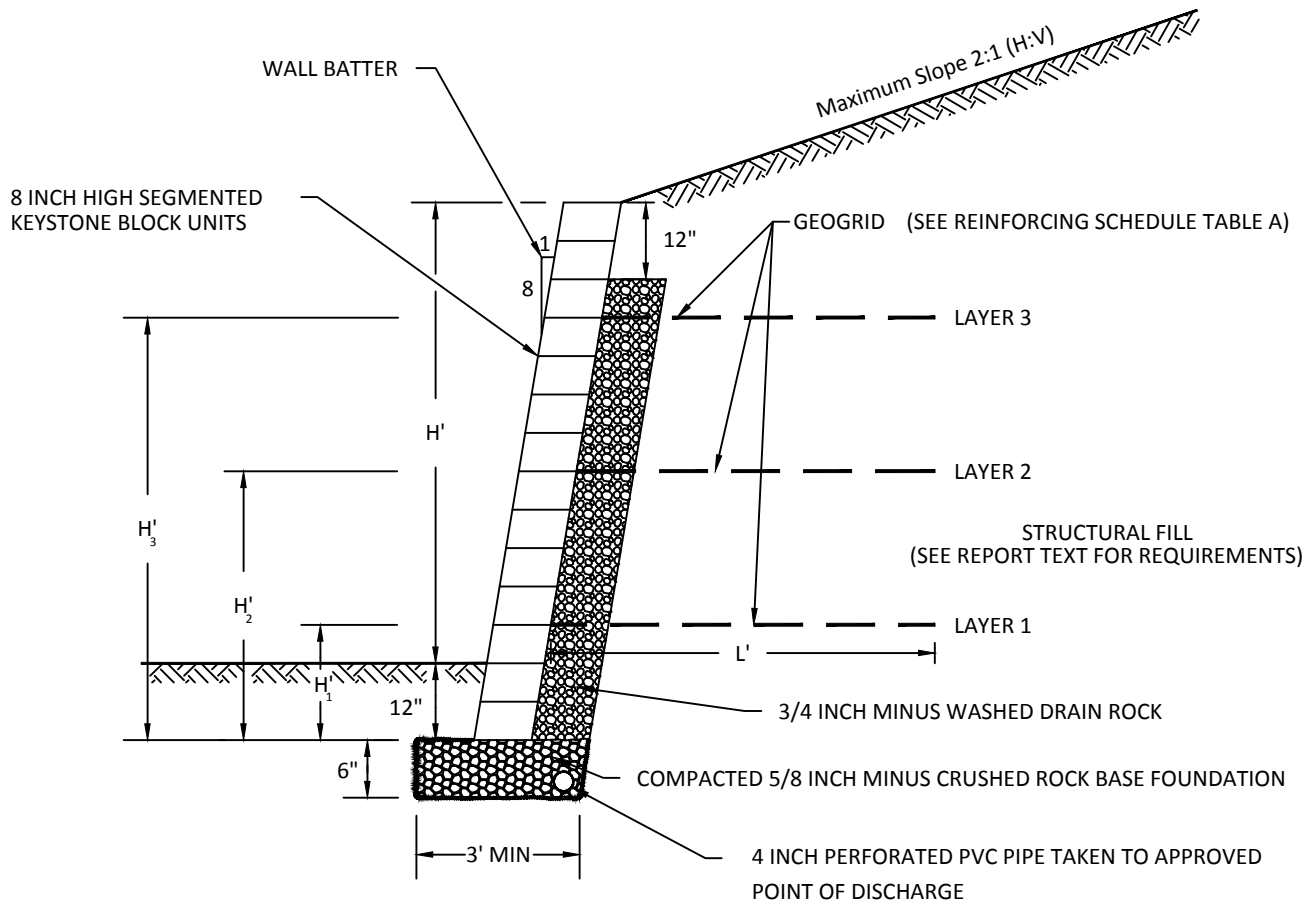
Bergsma Property		Figure 6
RGI Project Number 2015-046	Geogrid Reinforcing Schedule	Date Drawn: 04/2015
Address: Southeast Newport Way and 17th Avenue Northwest, Issaquah, Washington 98072

1. ALL GEOGRID LAYER HEIGHTS ARE MEASURED FROM TOP OF CRUSHED ROCK BASE FOUNDATION.
2. KEYSTONE BLOCK CONSTRUCTION AND CONNECTION OF GEOGRID TO WALL TO BE COMPLETED PER MANUFACTURERS SPECIFICATIONS.
3. MAXIMUM ALLOWABLE HEIGHT OF SLOPE BEHIND WALL : 5 FEET.

For preliminary planning purposes, the detail shown on Figure 5 and geogrid reinforcing schedule shown on Figure 6 may be used. We recommend RGI review the location and potential surcharge loading to segmental walls. These walls typically require a separate building permit. RGI can provide design plans for the permitting and construction of these walls.

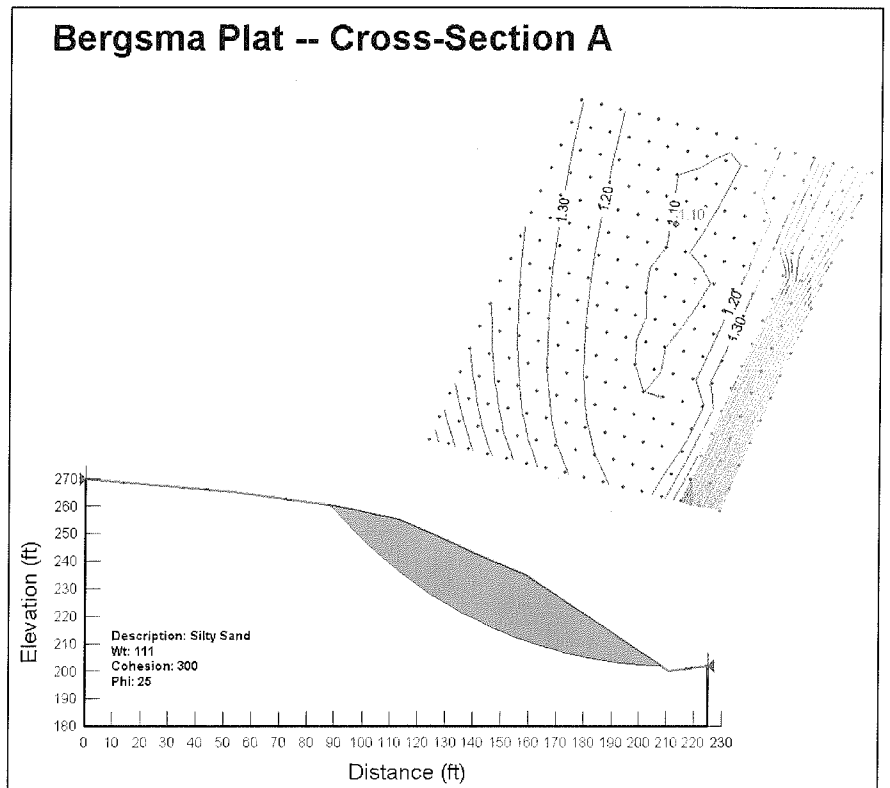
The figure (right) reveals the results of the dynamic slope model for section "A." The minimum dynamic factor of safety is equal to 1.1. The failure surface does not intersect the building location at the top of the slope.

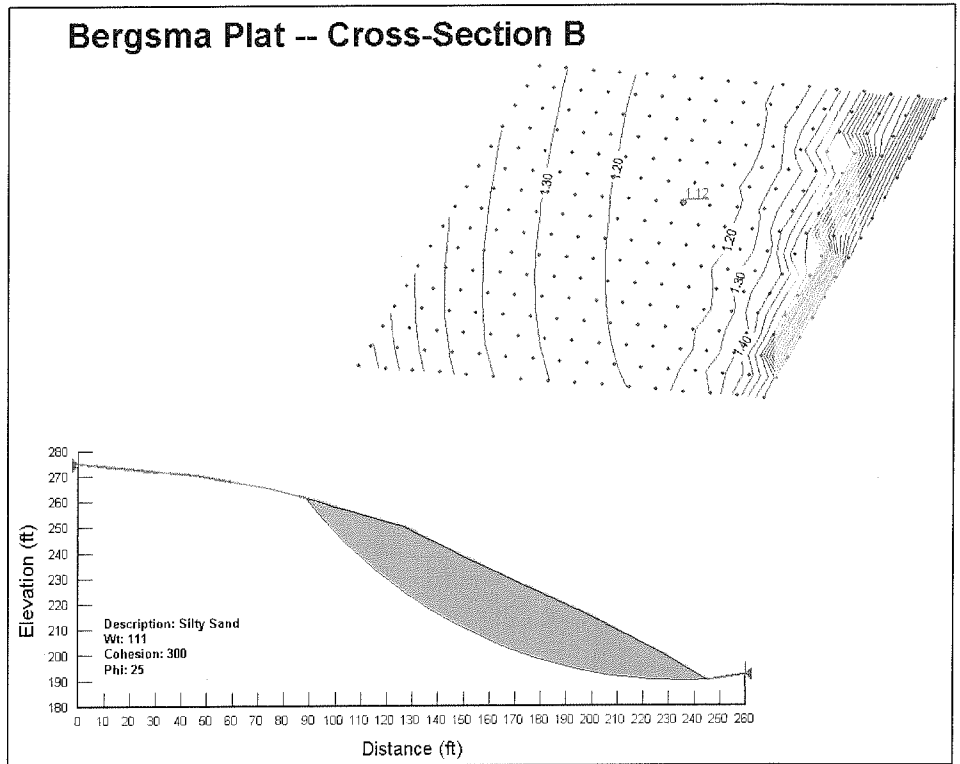
The figure (right) reveals the results of the dynamic slope model for section "B." The minimum dynamic factor of safety is equal to 1.12. The failure surface does not intersect the building location at the top of the slope.

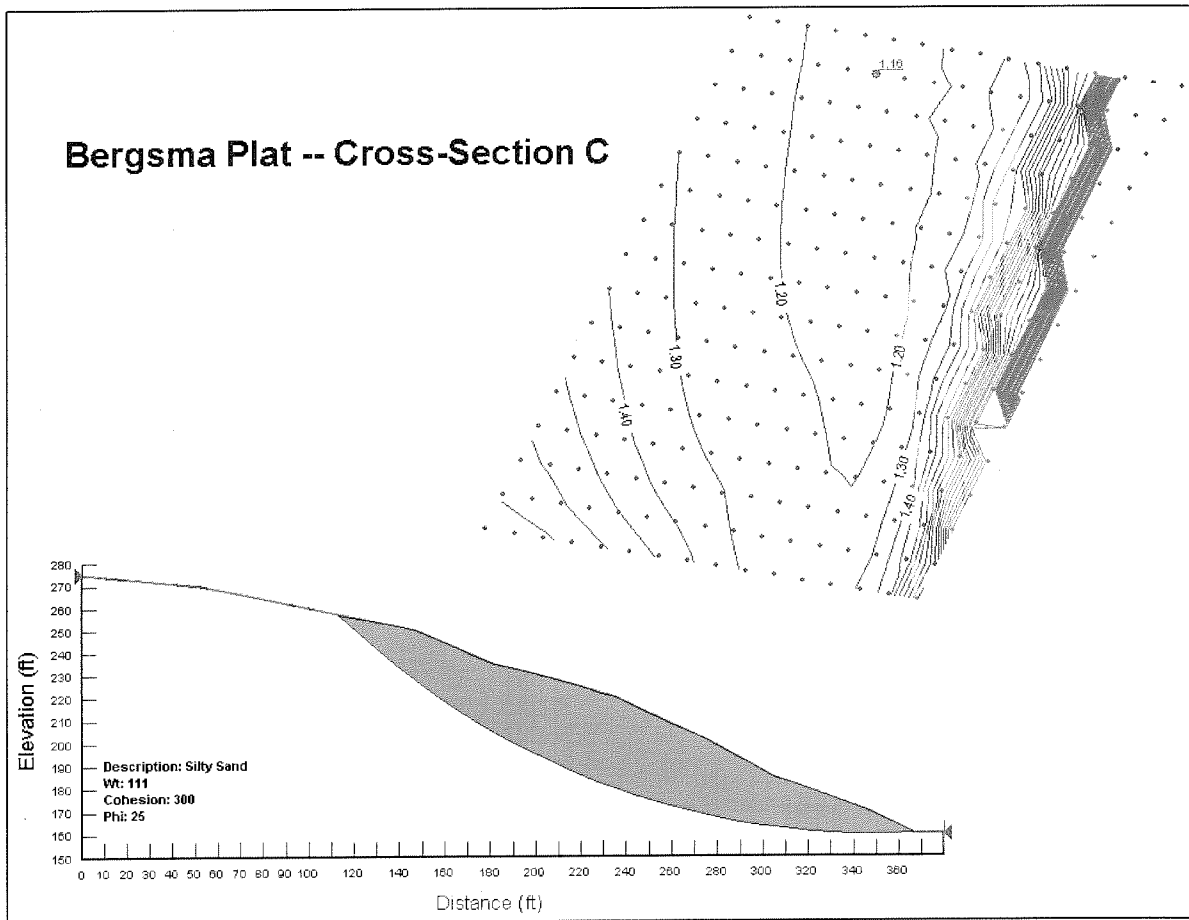
The figure (below) illustrates the results of the dynamic slope model for section "C." The minimum dynamic factor of safety is equal to 1.16. The failure surface does not intersect the building location at the top of the slope.

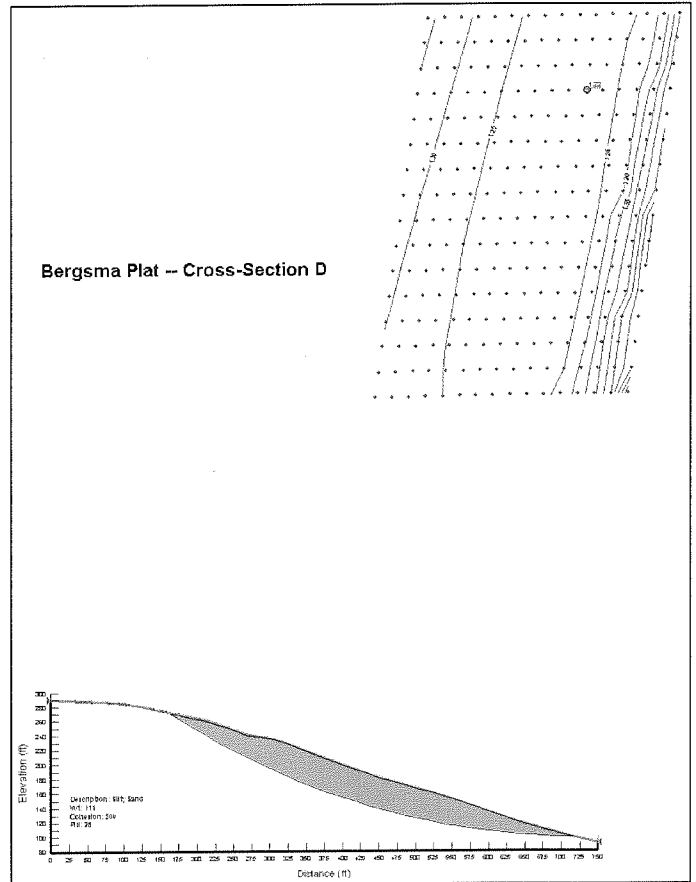
The figure (right) reveals the results of the dynamic slope model for section "D." The minimum dynamic factor of safety is equal to 1.22. The failure surface does not intersect the building location at the top of the slope.

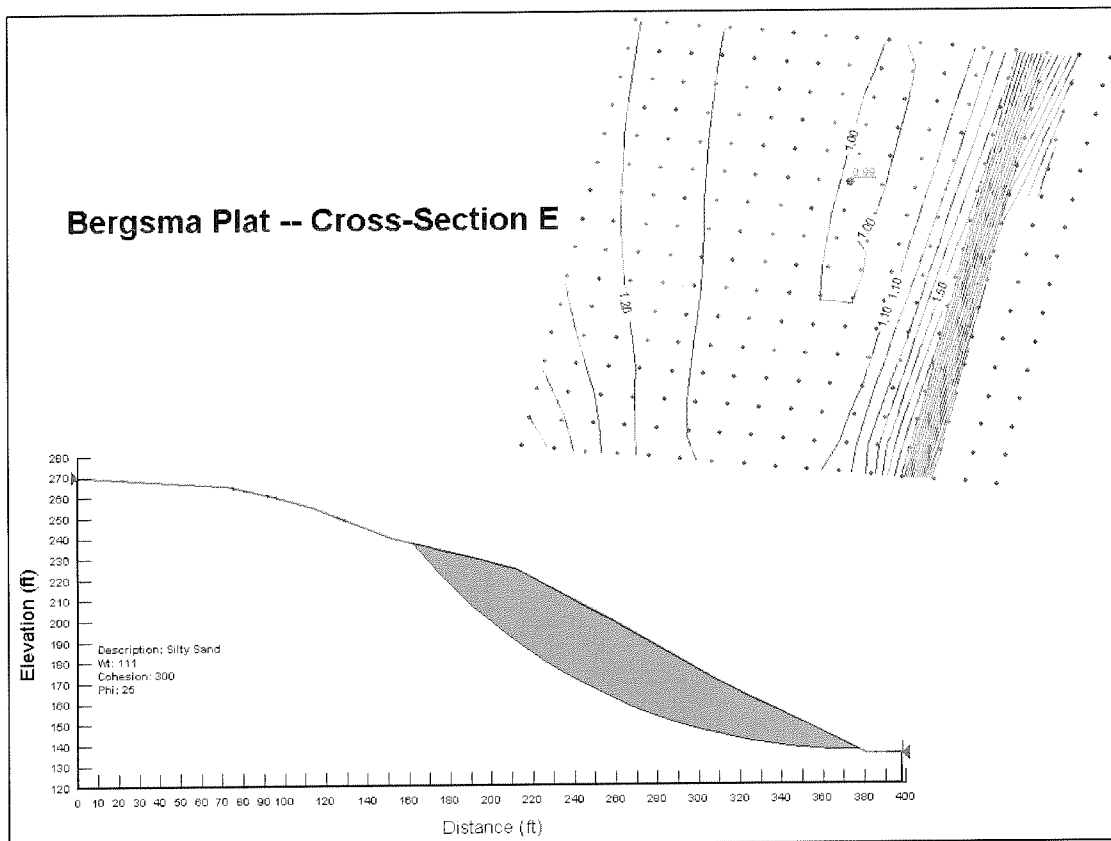
The figure (below) exposes the results of the dynamic slope model for section "A." The minimum dynamic factor of safety is equal to 0.99. The failure surface does intersect the building location at the top of the slope.

Results of the dynamic slope models indicate the overall site is "safe" under the existing conditions. If final grading or road construction alters the slope faces, re-evaluation of the new conditions may be prudent. If seepage or water bearing layers is encountered during road construction, a revised slope model should be evaluated.
